Manhole Inspection Summary

Manhole # S31C__043MH

Location Address: **501 PIERCE ST**

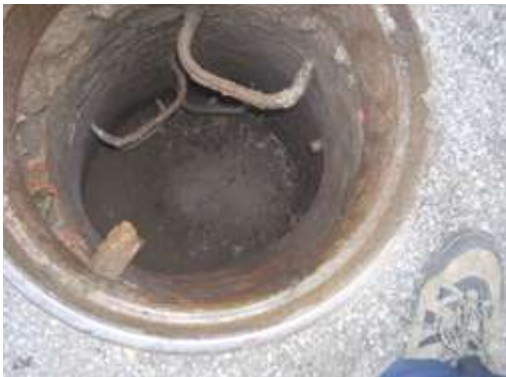
Defect 2

Count: **4** Missing: **0** ☒ **Corroded**

CORRODED STEPS

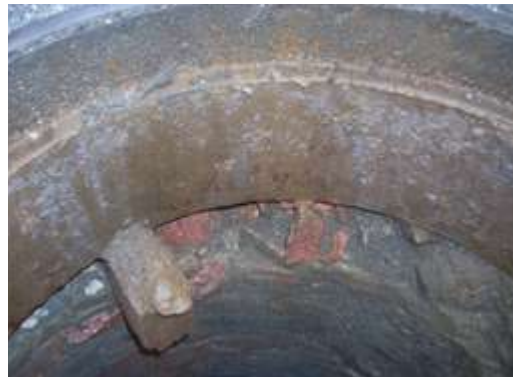
Defect 1

Condition: ☐ Sound ☐ Cracked ☐ Root Intrusion ☒ **Loose Brick** ☒ **Deteriorated**

CORBEL DETERIORATION AND
LOOSE BRICKS

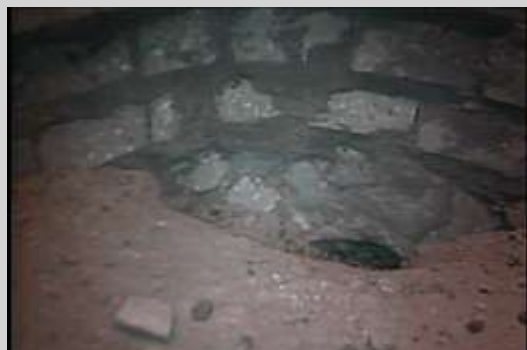
12 O'Clock Outflow

8 in. Circular Gravity Sewer
Pipe Out @ 12 O'Clock

Deposits: ☐ None ☒ **Mud** ☐ Sludge ☐ Debris ☐ Grease

Silt Depth: **8** (in.) Deposits Extent: **Heavy**
